THERMAL IMAGING CAMERAS FOR FIRE DETECTION AND PREVENTION ON BOARD OF MS ZAANDAM

FINAL RESEARCH

HZ UNIVERSITY OF APPLIED SCIENCES DE RUYTER ACCADEMY

GEORGY KUKUSHKIN

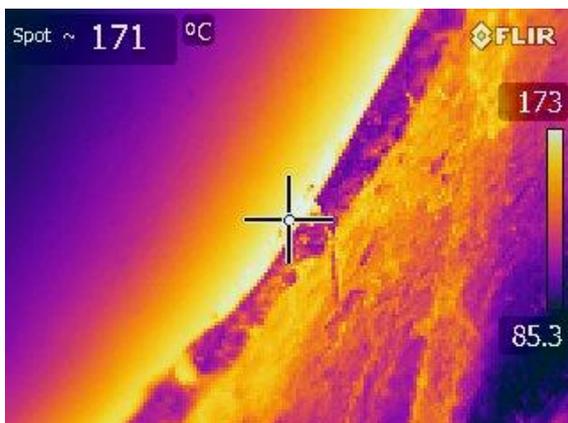
The temperature of the casing of an electric motor is around 90°C. The highest temperature around the burners is 173°C. The temperatures of the fuel supply lines to the burners are around 90°C (depending on the fuel). The temperature of the burner's hatch cover is around 90°C (see figures 15 and 16).

Figure 15: Highest temperature around the burner

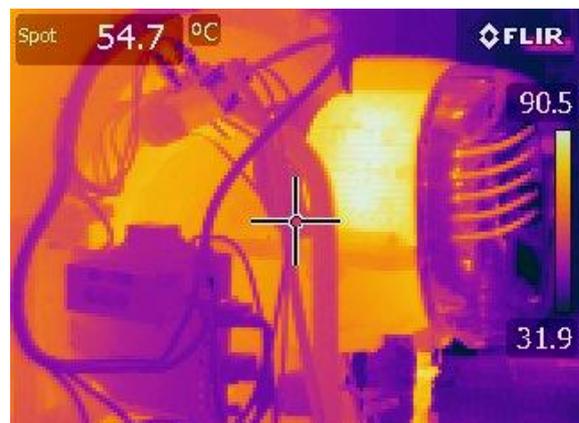
Figure 16: Temperature of the motor casing

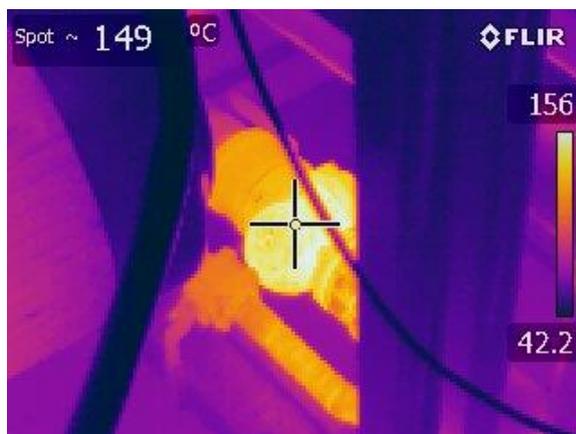
Figure 17: The temperature of the steam trap

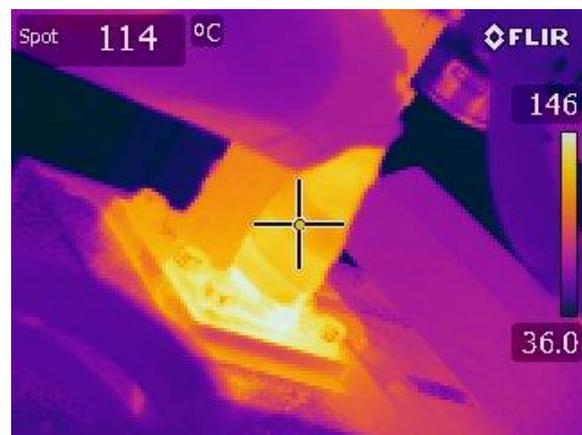
Figure 18: The temperature of the steam supply line to the heater

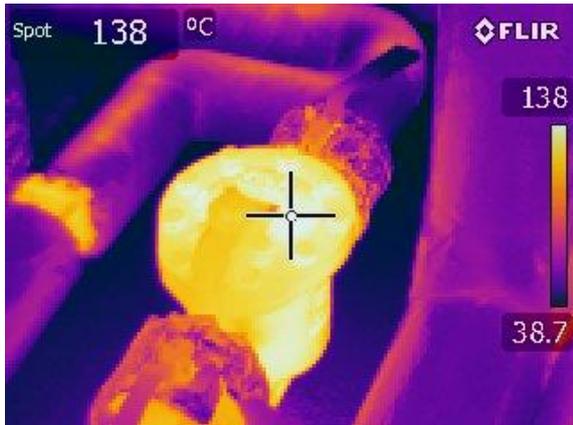
Beside the purifiers, there are two marine diesel oil/heavy fuel booster units installed in the purifier room. The possibility of heavy fuel leakage or marine diesel oil leakage onto the hot parts is high. After investigation with FLIR thermal imaging camera on board, it seems that the temperatures at some areas around the booster units are high. The surface temperature of a steam trap is 138°C and surface temperature of a booster pump is 139°C (see figures 19 and 20).

Figure 19: Temperature of the steam trap

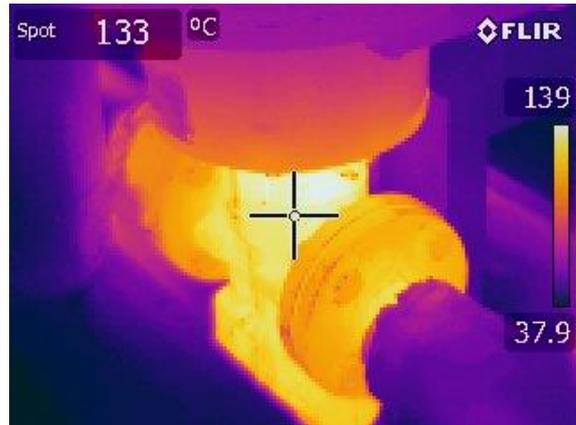
Figure 20: Temperature of the booster pump

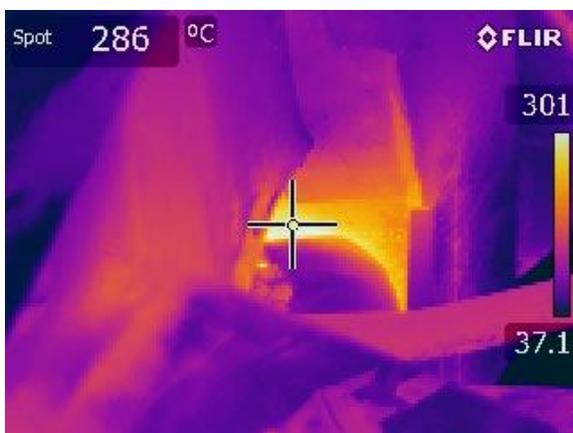
Totally two hotspots were found with thermal imaging camera. One is 234°C and another one is 301°C.

Figure 21: Hotspot near turbocharger

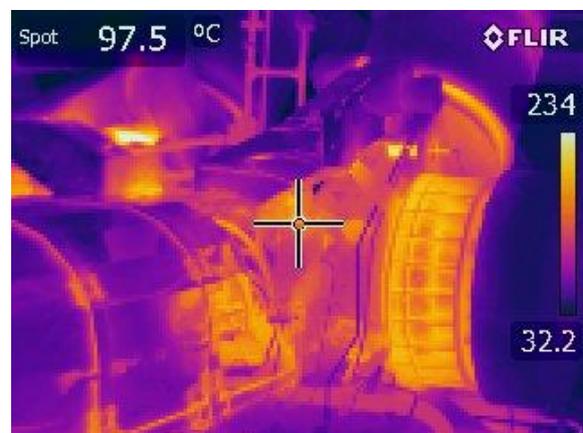
Figure 22: Hotspot near turbochargers

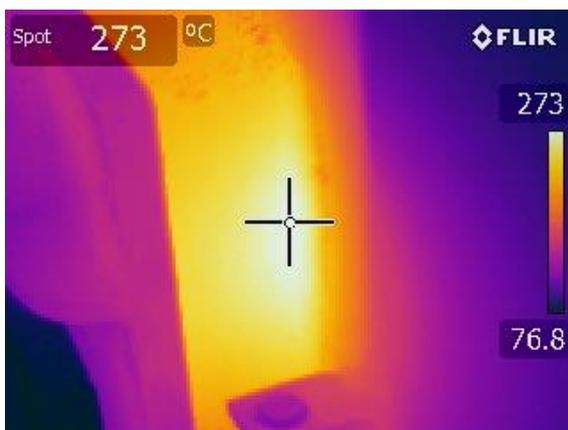
The average casing temperature is around 100°C. The temperature around the burners is around 120°C. Totally three hotspots were found with thermal imaging camera. One is 232°C, another one is 262°C and the last one is around 273°C (see figures 23 and 24).

Figure 23: Hotspot near the hatch cover

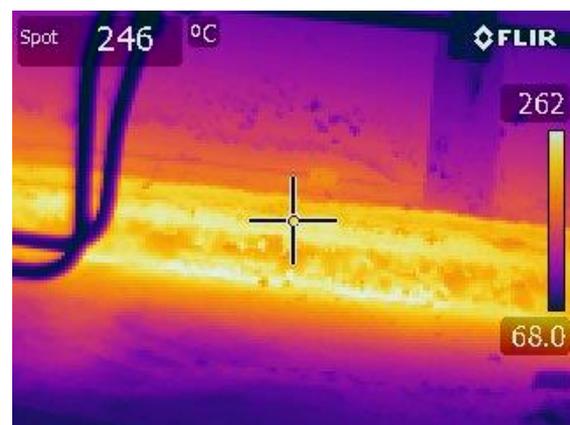
Figure 24: Hotspot near the secondary burner

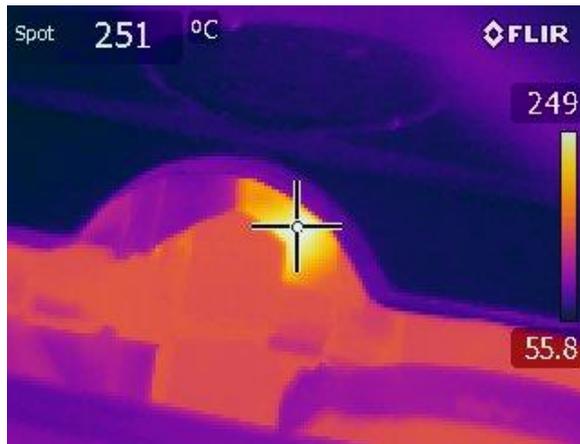
Figure 25: Hotspot between cylinders

The average temperature around the emergency diesel generator is 90°C. The average temperature on the filters is around 92 -93°C. However, there were two hotspots found between the cylinders. One is 249°C and another one is 327°C

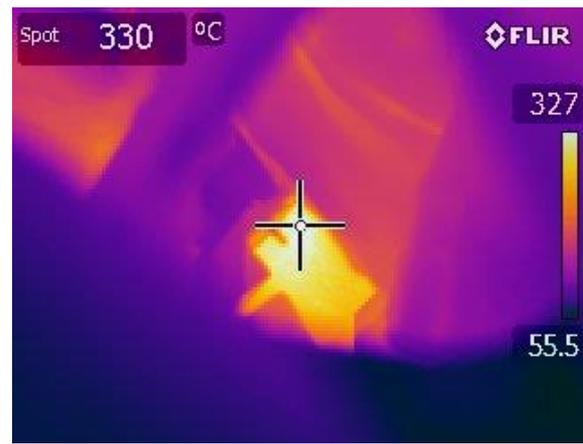
Figure 26: Hotspot between cylinders

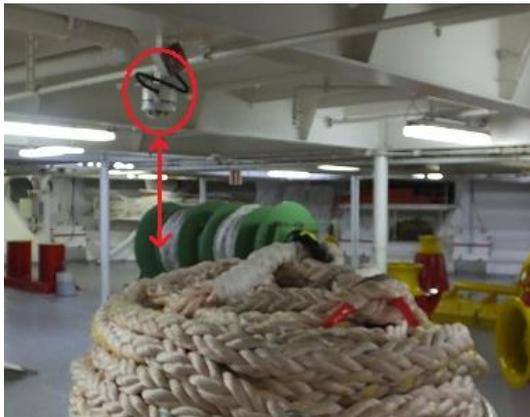
Figure 27: Position of the heat detector to the mooring lines

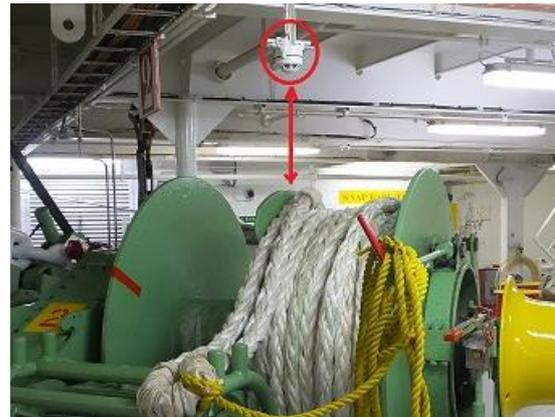
Figure 28: Position of the heat detectors to the mooring winches
