Animal burrows in your levees

What does it take to keep your levees safe from animals?

Vana Tsimopoulou & André Koelewijn

Polder2C's final conference, Antwerp 7-9 March 2023

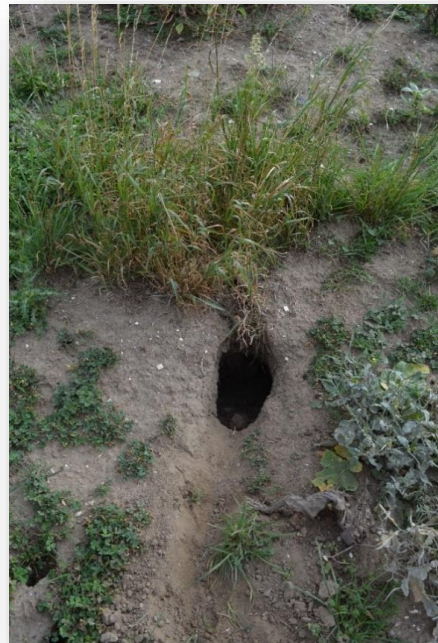
Burrow on landward slope, diameter approx. 25cm

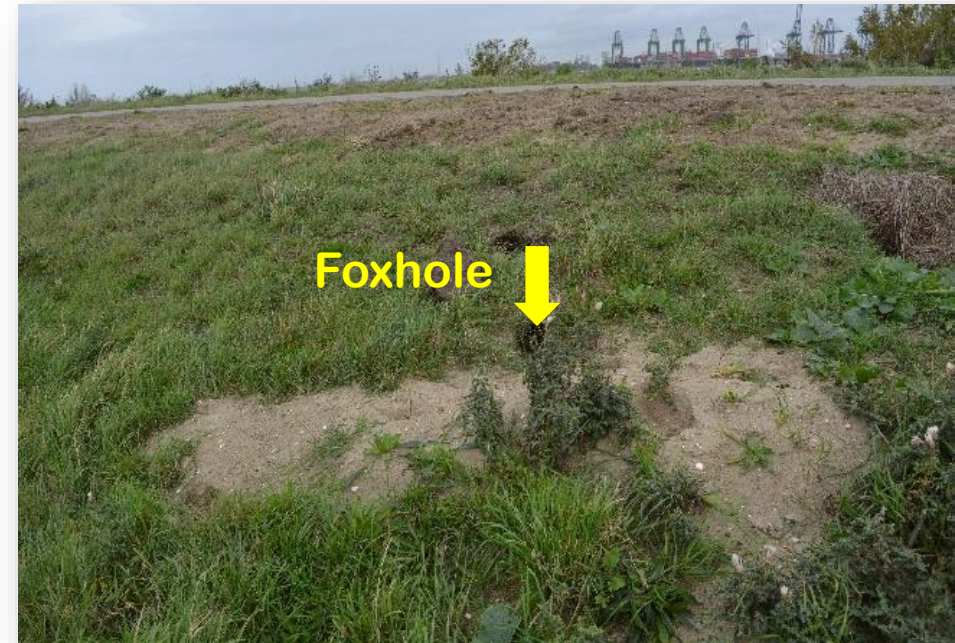
Sand deposit under foxhole

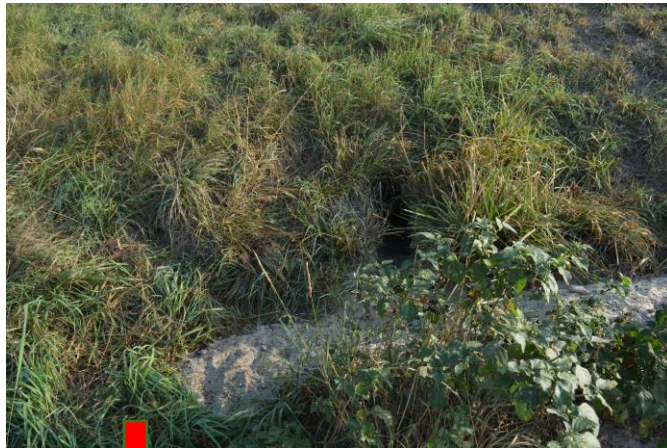
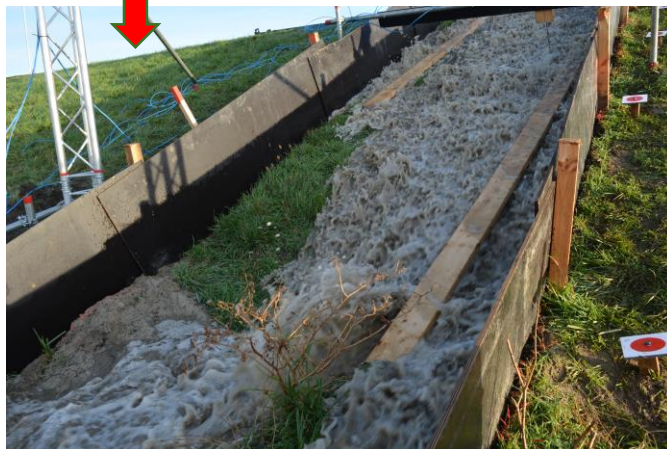
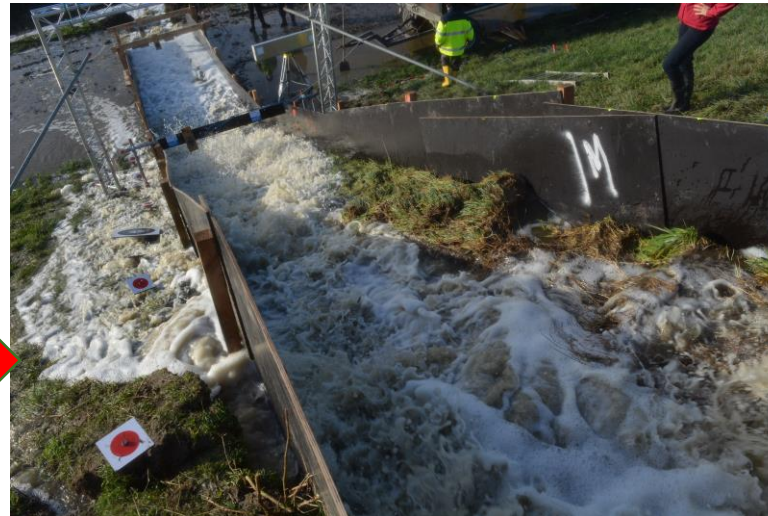
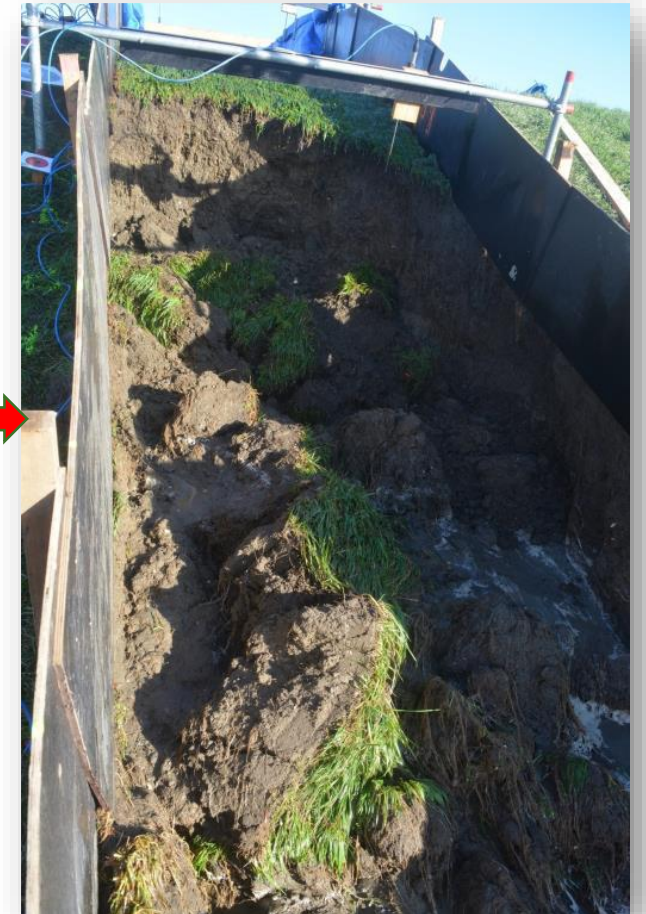
Overflow test on a fox/rabbit hole hole (1 h 13 min)

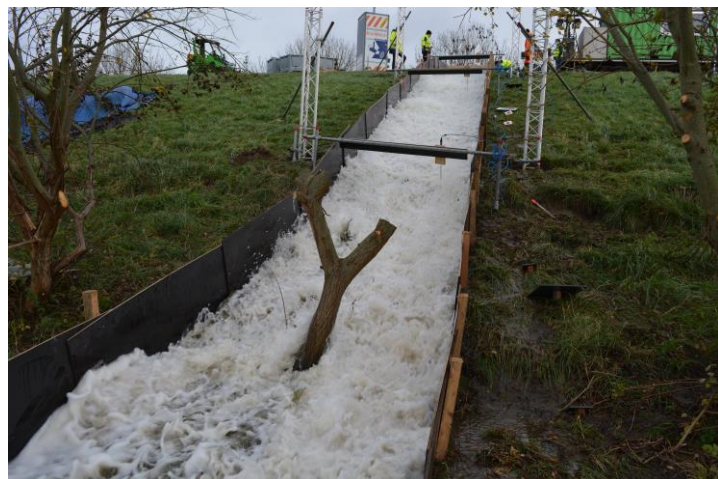
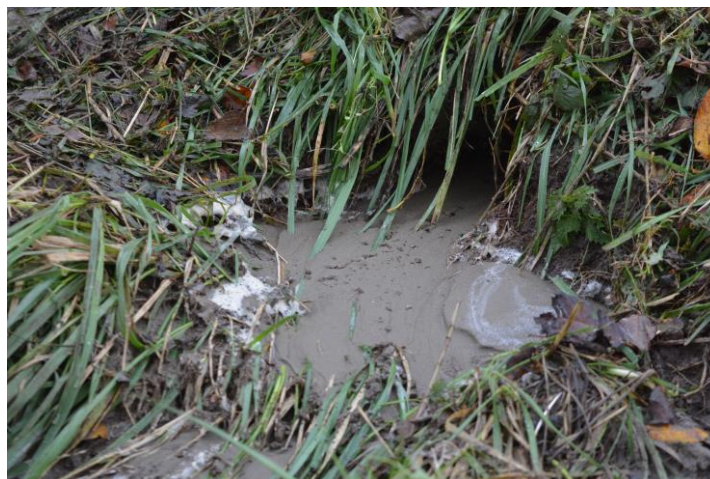
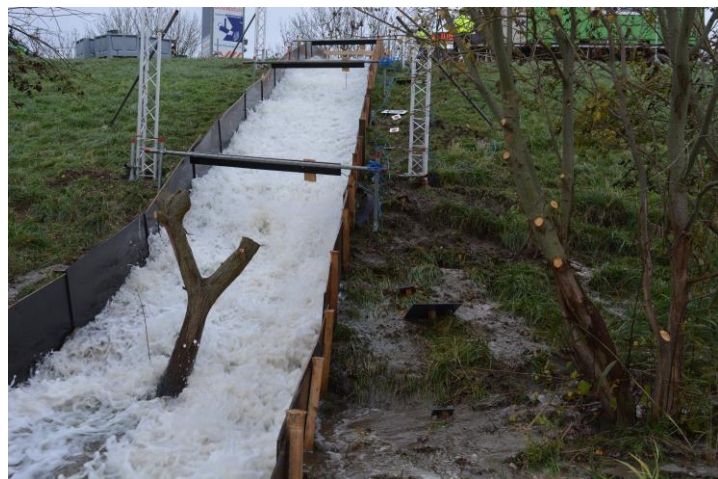
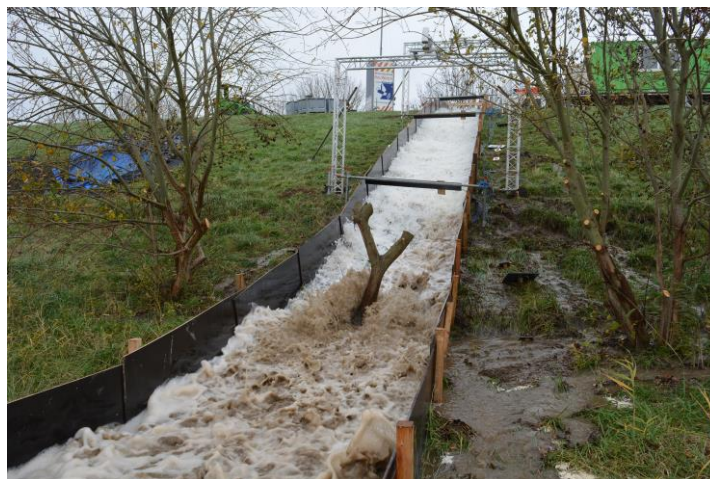
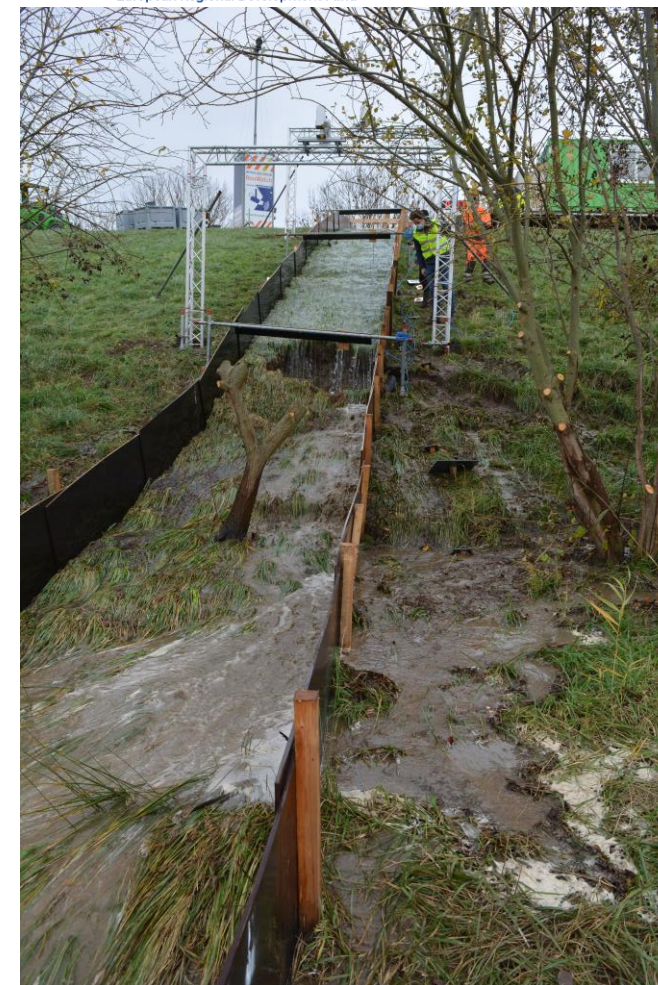
Overflow test with mole burrows (1 h 7 min)

- Another test with a tree failed by mole burrows after 13 hours of flow
- Tests where no failure occurred, had no mole burrows
- Elsewhere, wave overtopping tests showed a remarkable influence of the presence/absence of mole burrows (MSc thesis Peter van Dijk, TU Delft, 31 August 2021)
- Yet, how to quantify this influence, in general or in specific cases...?

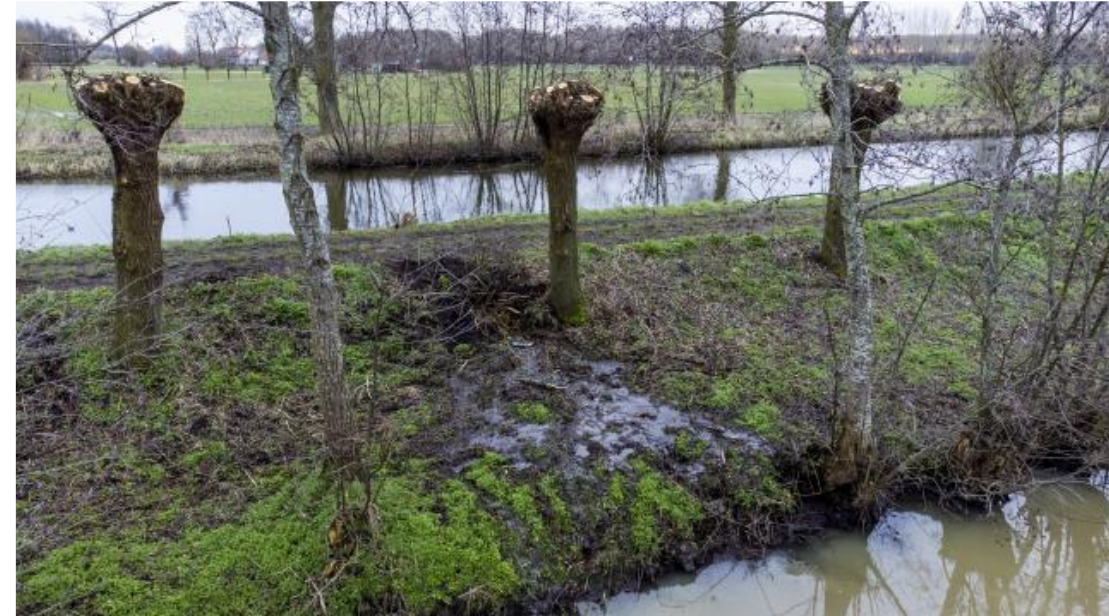
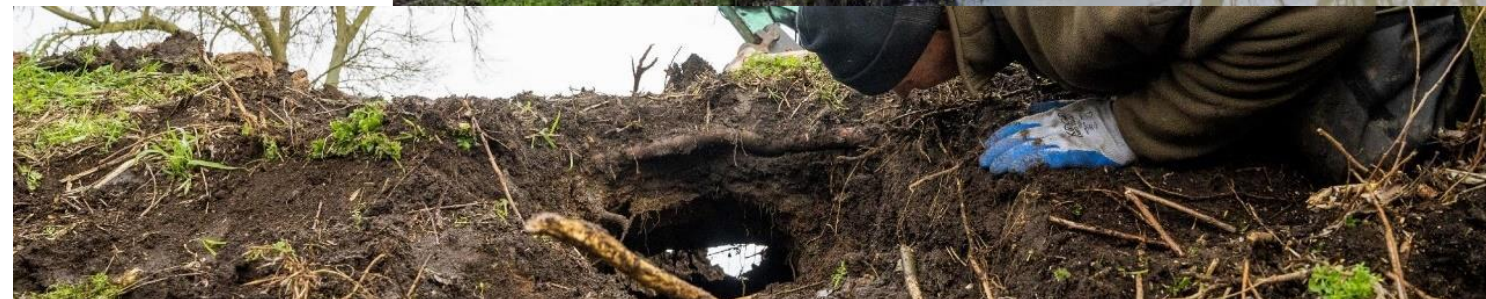
- A beaver hole through a regional dike (Zijkade near Vianen, Netherlands)

Did this dike fail or not?

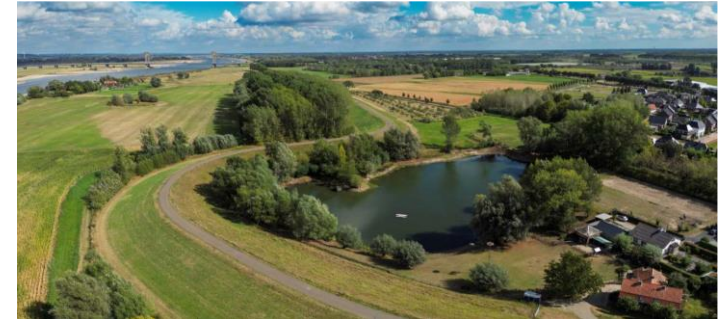
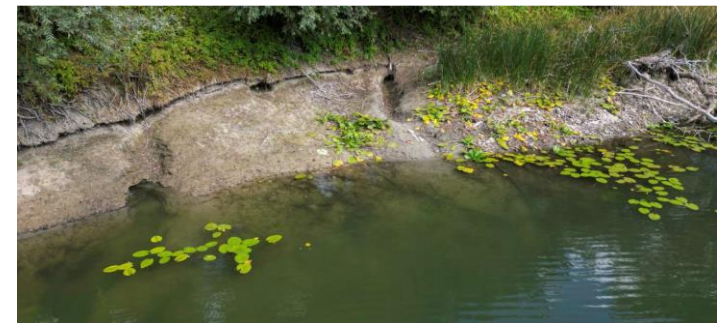
Beaver burrow system at Wamel (NL), Summer 2022

Scenario at highwater conditions:

1. Burrows attract more water than drainage system *0.5-0.8*
2. Fluidisation of lower landside toe *probability of 0.1-0.5*
3. Instability of entire slope – *probability of failure 1.48×10^{-4} per year with burrows + step 1,2 | 3.55×10^{-9} per year for completely intact situation*
4. Further failure of remaining profile *prob. 0.5-0.9*
5. Emergency measures fail *probability of 0.1-0.9*

Altogether 100 – 14 000 higher failure prob.

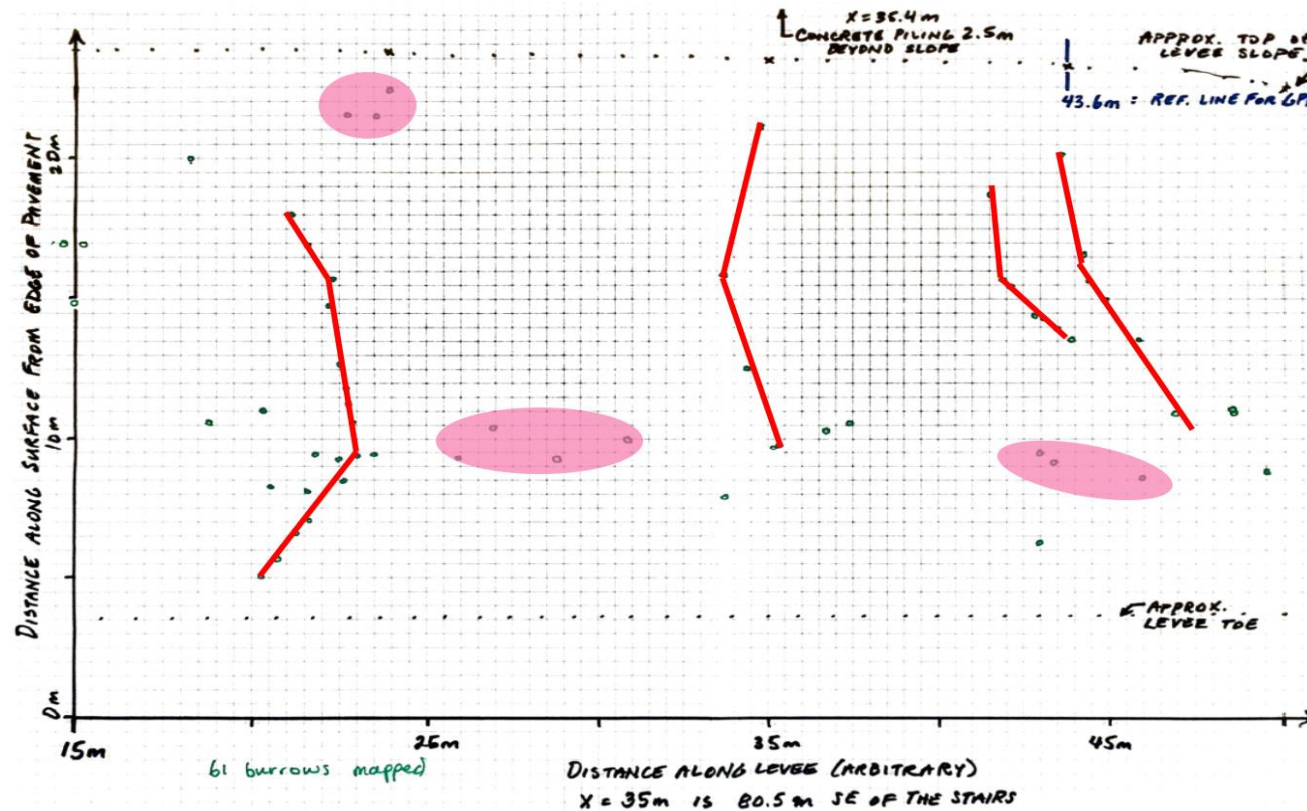
Spatial distribution patterns

- Clusters (mice & moles)
- Lines (moles)

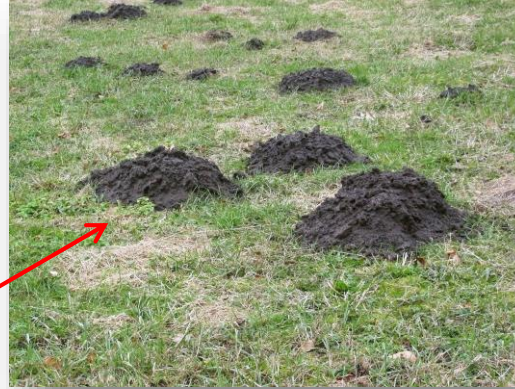
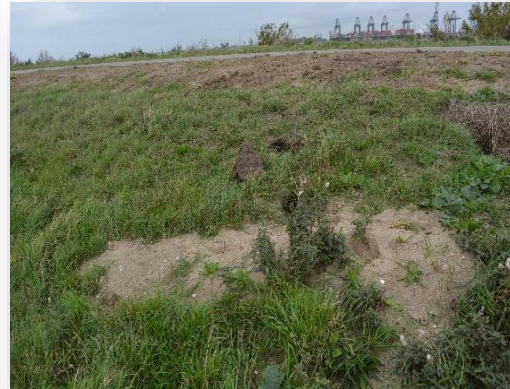
Other visual clues

- Clay mounds (moles)
- Patches of sand (larger animals)

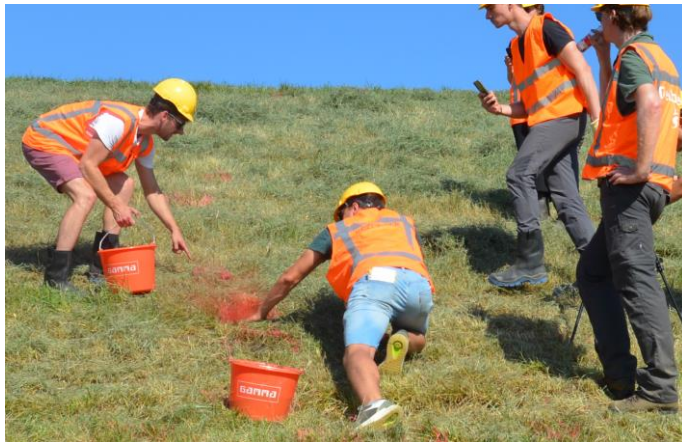
Version 1: Hedwigepolder (09-21)

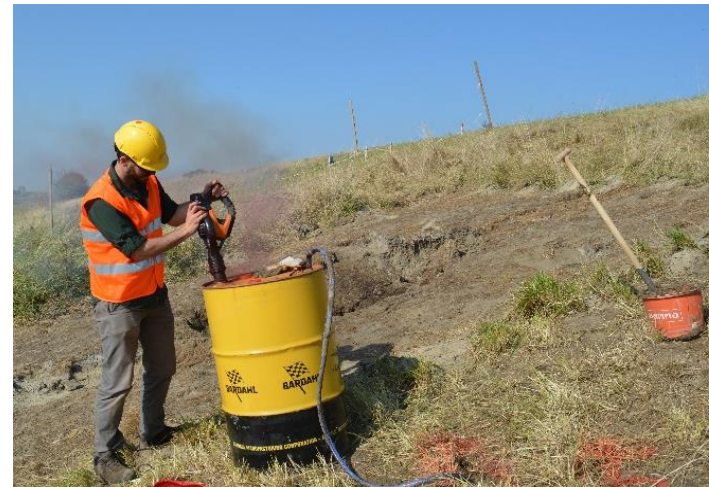
Version 2: Prosperpolder (10-21)

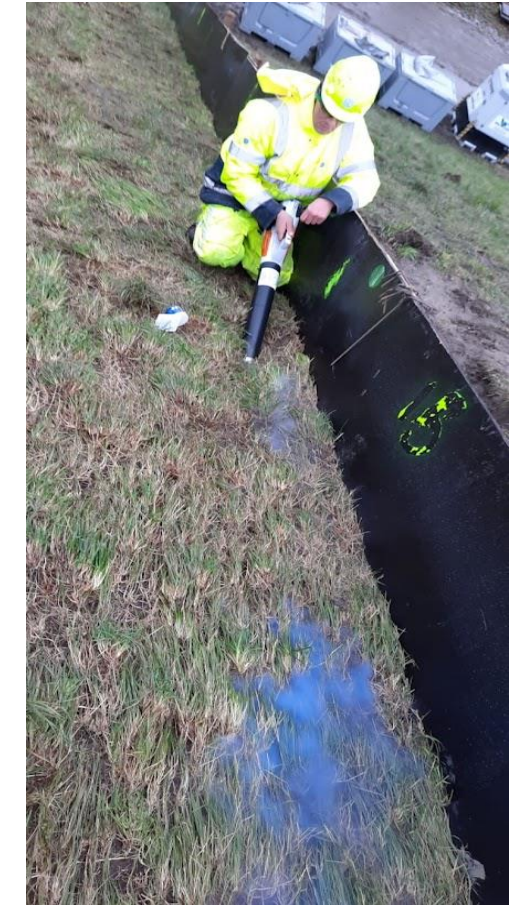
Version 3 Hedwigepolder (12-21)

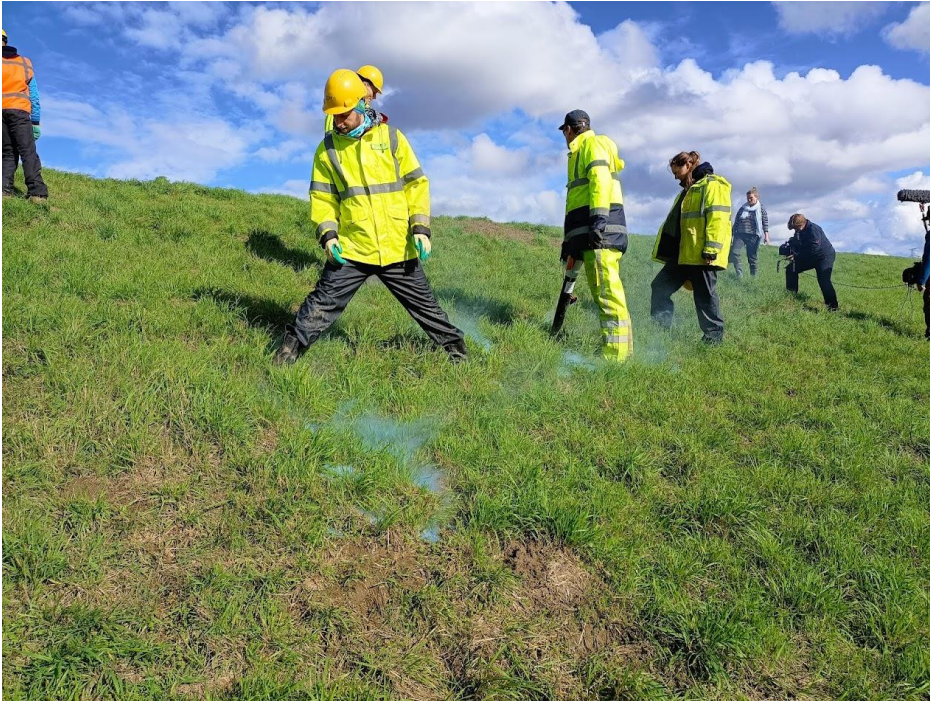
Evaluation

- (+) Easy to apply
- (+) Complementary to visual inspections
- (-) Effect on health and safety of animals unknown

- (+) Immediate results
- (+) Effective in most trials

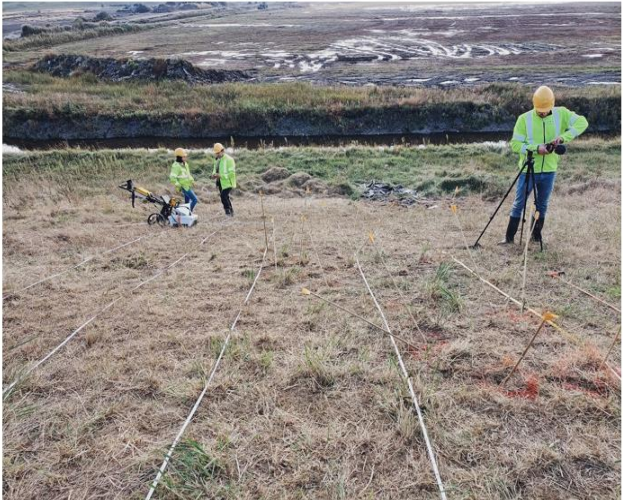
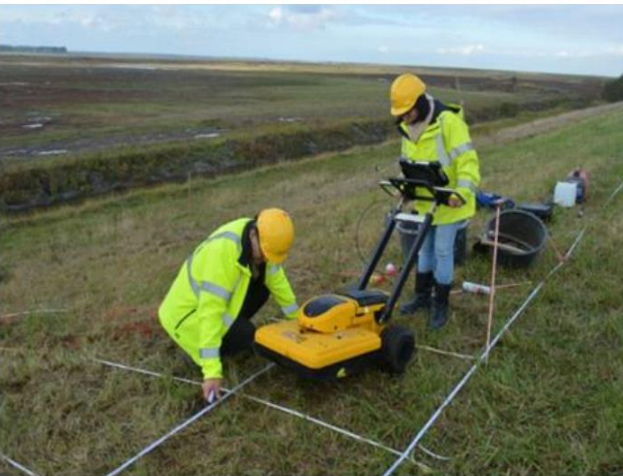
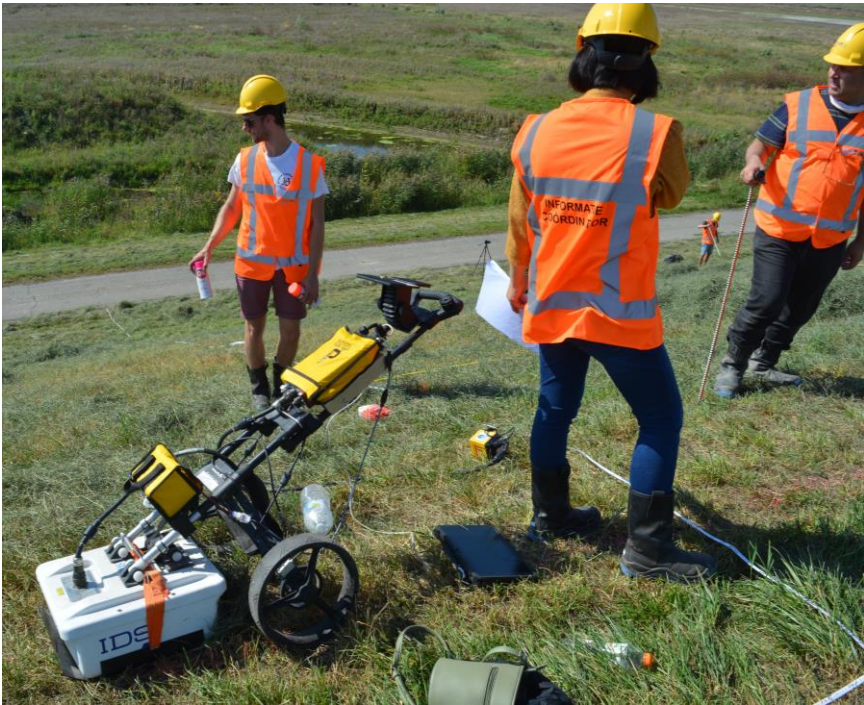
2. Ground penetrating radar

Non-destructive technique

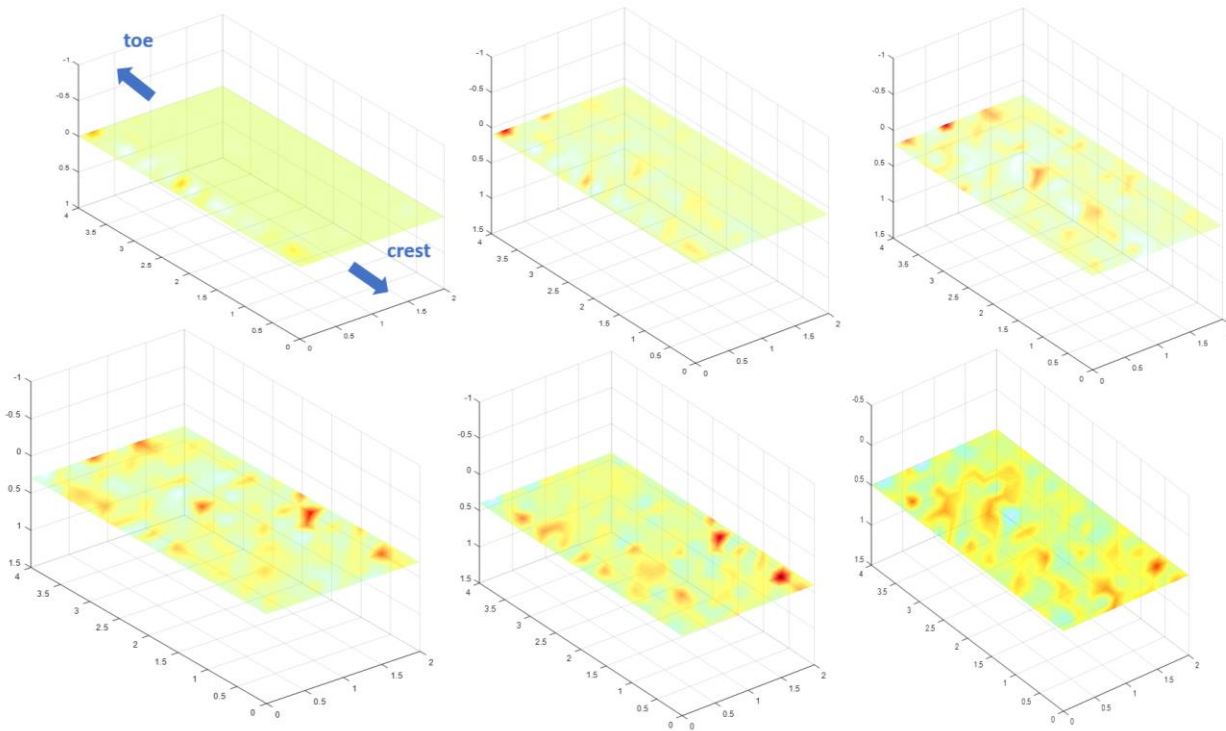
Sample of results & preliminary findings

- (+) Possible on a slope!
- (-) Weather conditions influence accuracy
- (-) Results not readily available in the field

- (-) Scans with 2GHz provide a satisfactory picture of the first 50cm, less suitable for large burrows
- (+) More accurate than inspection with a probe (depth and geometry)

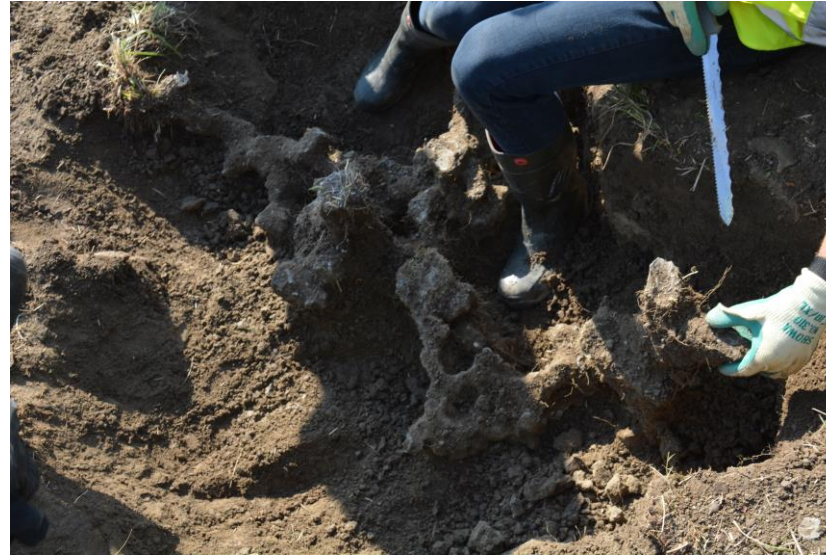
Linear mole system

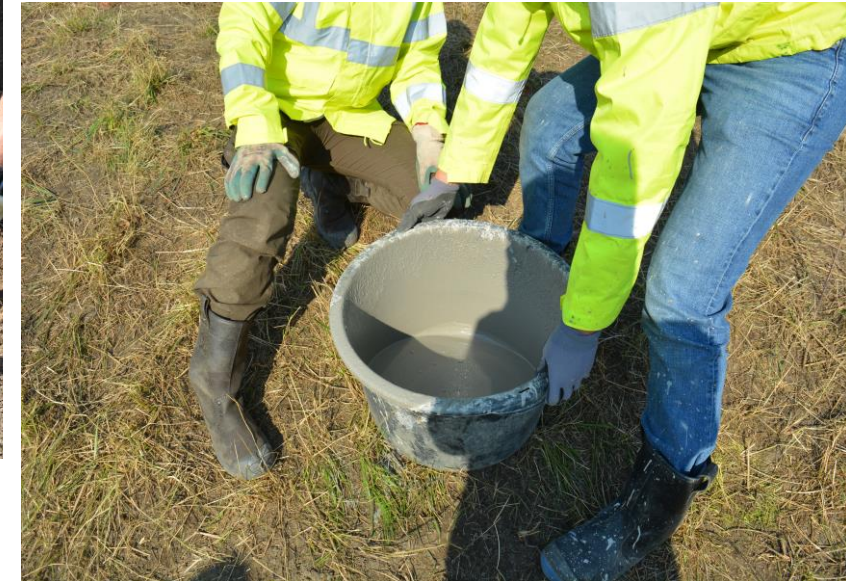
Cluster of mice burrows

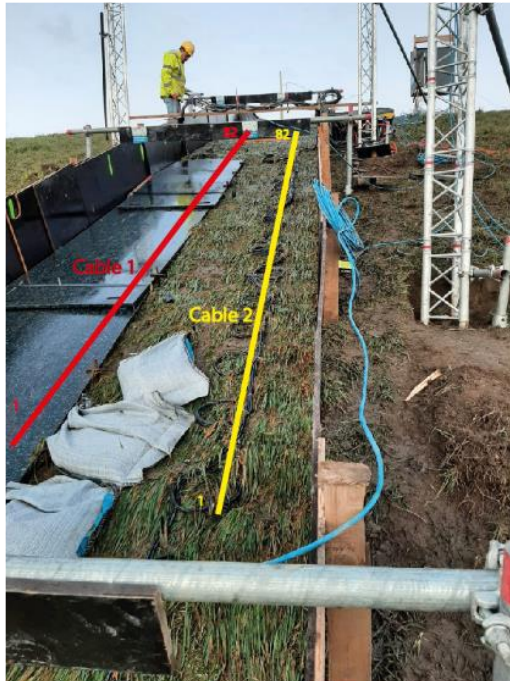
Timeseries of electric resistivity in the subsoil during an overflow test

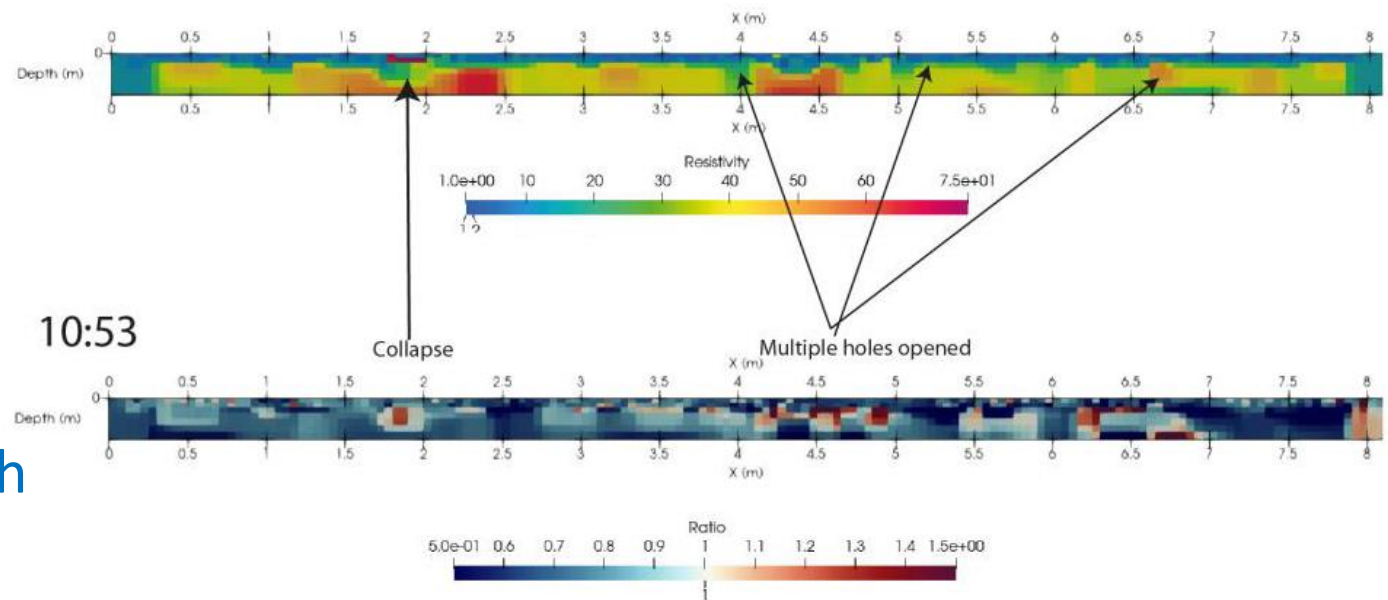
1. Cavities being filled with water
2. Creation of new cavities (filled with air or water)
3. Collapsing of existing cavities
4. Cavities starting to connect with each other

Basis 10:04 Flow of 5.8m³/min

➤ Promising results for *modelling of internal erosion* processes.

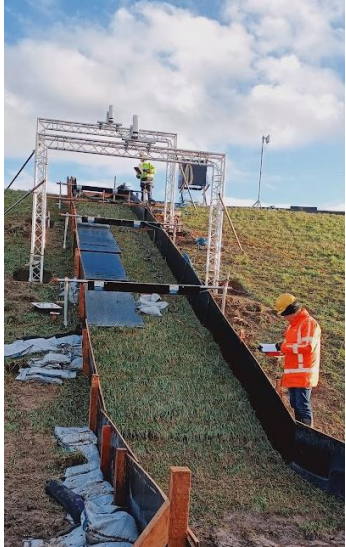
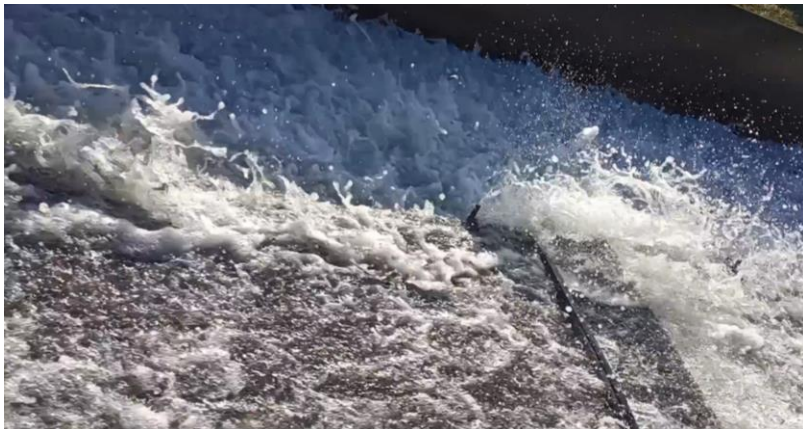
Low-cost repair with road plates

Overflow experiment, November 2021

- (+) Very easy installation
- (+) Low-cost
- (-) Configuration is site-specific

- (+) Solution remained intact after 10hrs & 18min of testing
- (+) Similar approaches worked in other LLHPP activities
- (0) Sandbags did not play a role

➤ *Further testing is needed for benchmarking*
