THERMAL IMAGING CAMERAS FOR FIRE DETECTION AND PREVENTION ON BOARD OF MS ZAANDAM

FINAL RESEARCH

HZ UNIVERSITY OF APPLIED SCIENCES DE RUYTER ACCADEMY

GEORGY KUKUSHKIN

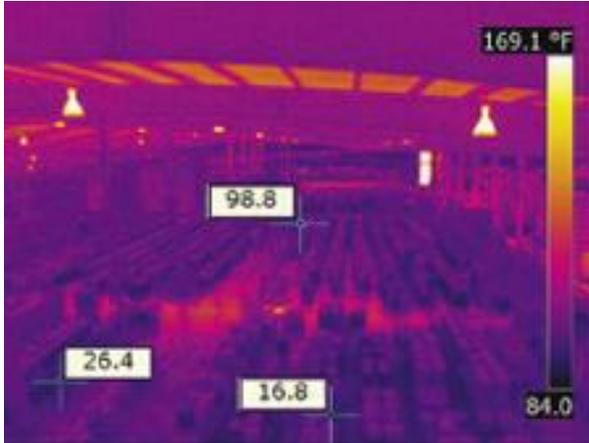
Figure 6: Thermal imaging detected a hotspot (FLIR, 2015)

Figures 6 and 7 represent a thermal video recording of a warehouse stocked with wood. From figure 6 can be clearly observed that there are three different temperature readings. The first two temperature spots are -3.1°C and -8.4°C and the third temperature reading is 37.1°C . Comparing the difference between the readings it is obvious that the last reading is abnormally high. Figure 7 shows that thermal imaging camera kept the hotspot monitoring and observed a further temperature increasing. At the moment when temperature increasing reached the set point established by user thermal imager activated alarm. (FLIR, 2015)

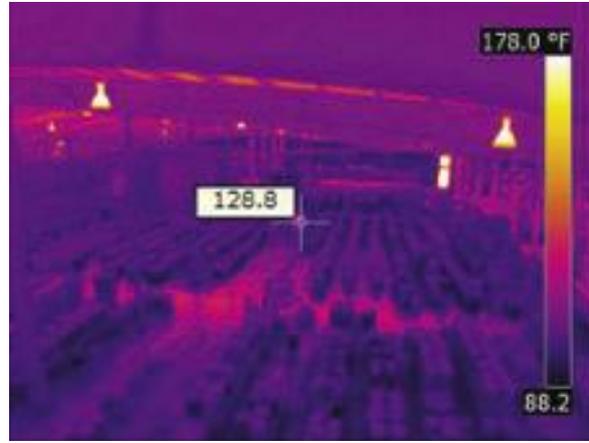
Figure 7: Thermal imaging camera monitored temperature increasing (FLIR, 2015)

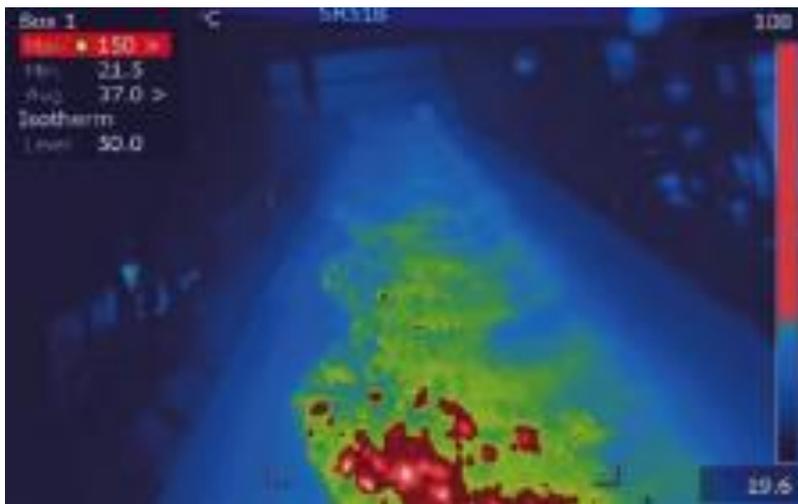
Figure 8: Abnormal high temperature is detected during transport (FLIR, 2015)

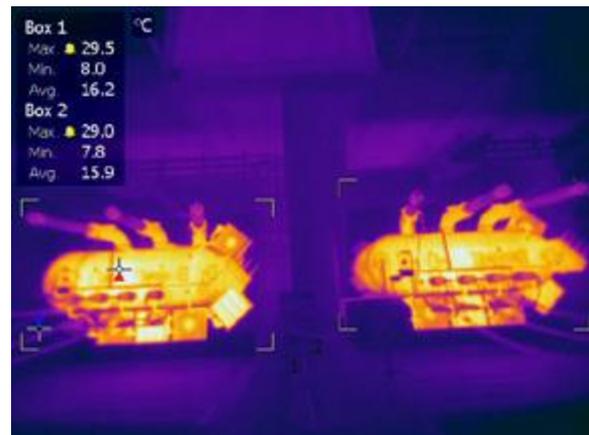
Figure 12: Condition monitoring of the transformers (FLIR, 2015)

Figure 12 shows a thermal video recording of two similar transformers. As can be seen, the temperatures are approximately the same, it means that there are no abnormal temperatures increases inside the electrical components.
